# PHOTOGRAPHIC ENGINEERING ANALYSIS OF TANZANIAN WELL MAINTENANCE UNIT

Andrew W.S. Ainger

Date: 17<sup>th</sup> April 2020

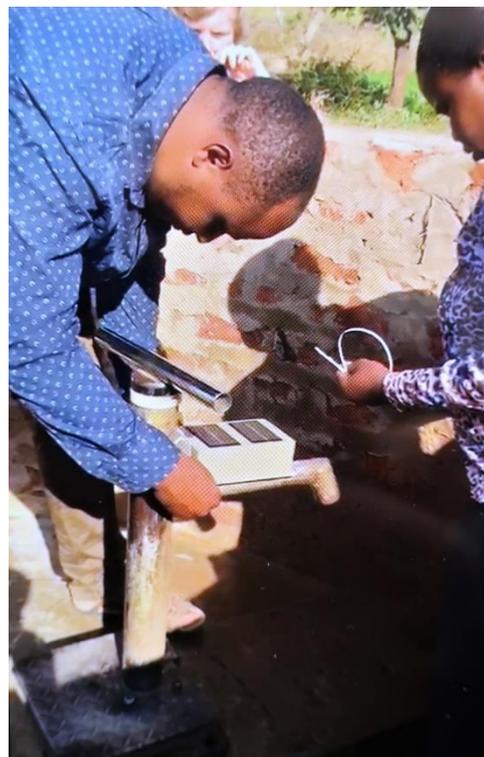
**Figure 1:**

### **AWSOM Unit Installation**

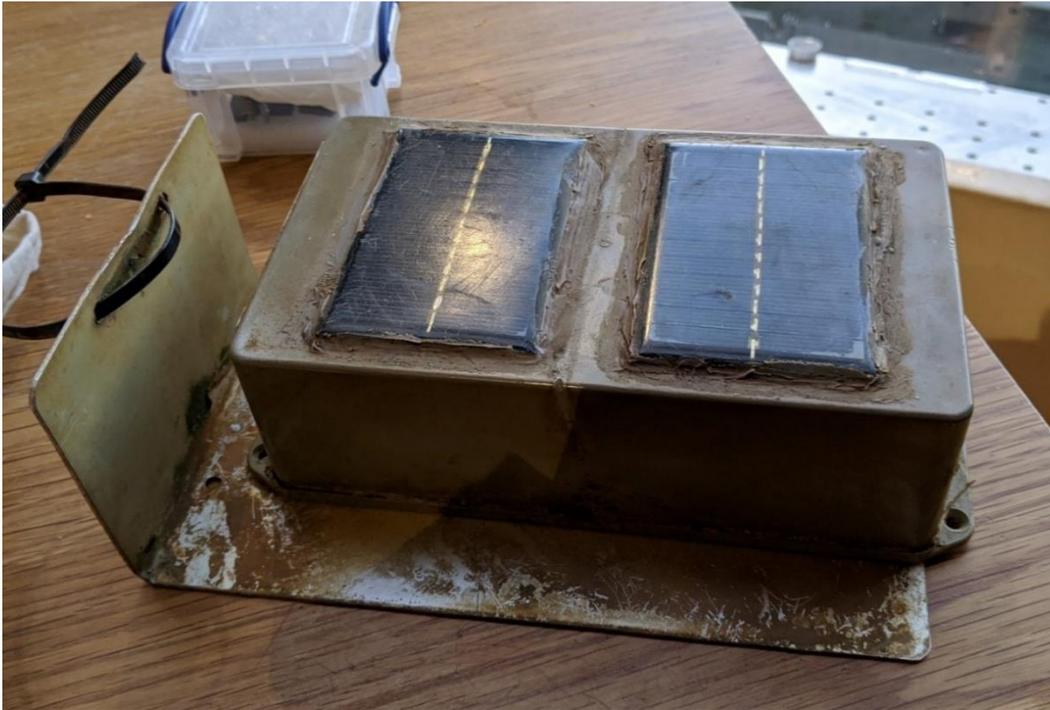
**Figure 2: Unit #3888 Returned**

Figure 2 shows the unit after being in Tanzania for almost a year. The rust-like color of the unit demonstrates the high levels of dust (and possibly iron salts) in the soil.

The housing has proved to be mechanically robust and has not cracked or broken. The lifting of the solar cells that was found on the previous versions (where the solar cells were affixed too close to each other which did not allow for thermal expansion) has not occurred.

The upgraded twin solar-cell design with its two-part epoxy adhesive has worked well. Upon arrival in the UK the batteries were charged (5.2v) demonstrating that the twin solar cell approach works satisfactorily.

Figure 2: The unit at the UK airport.

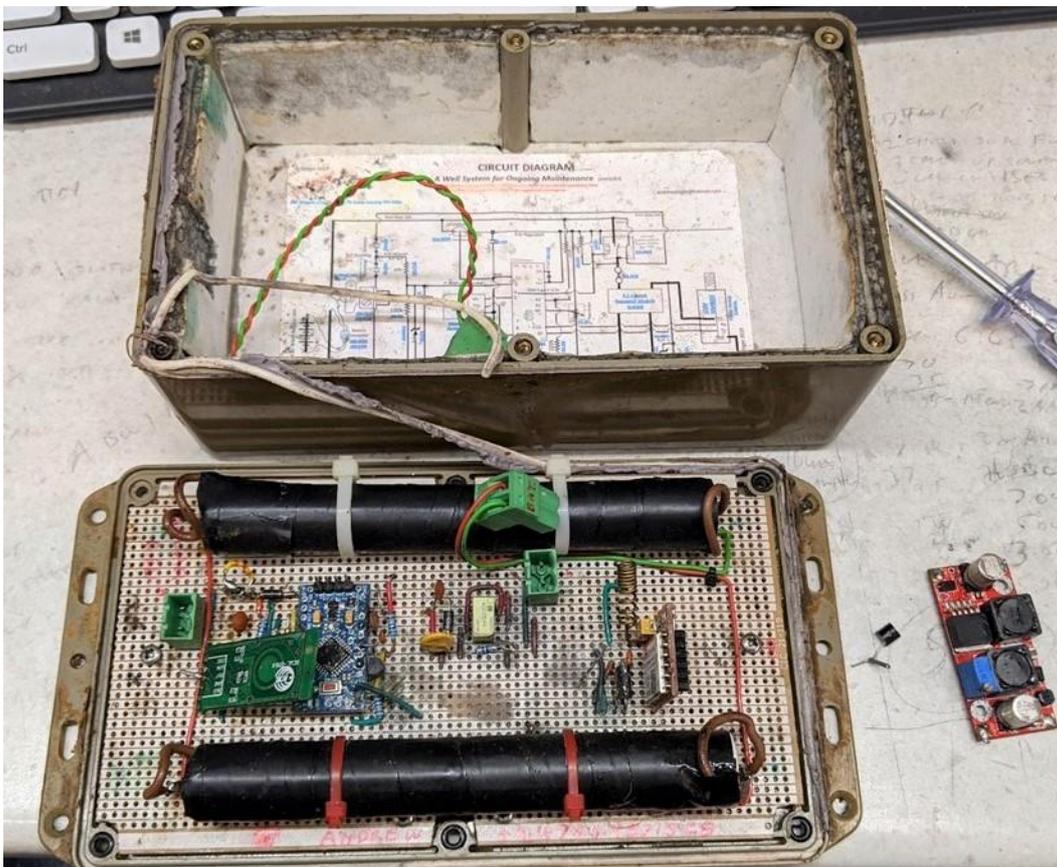
**Figure 3: Returned Unit First Opening**

Figure 3 shows the unit as first opened. This demonstrates the stressed areas.

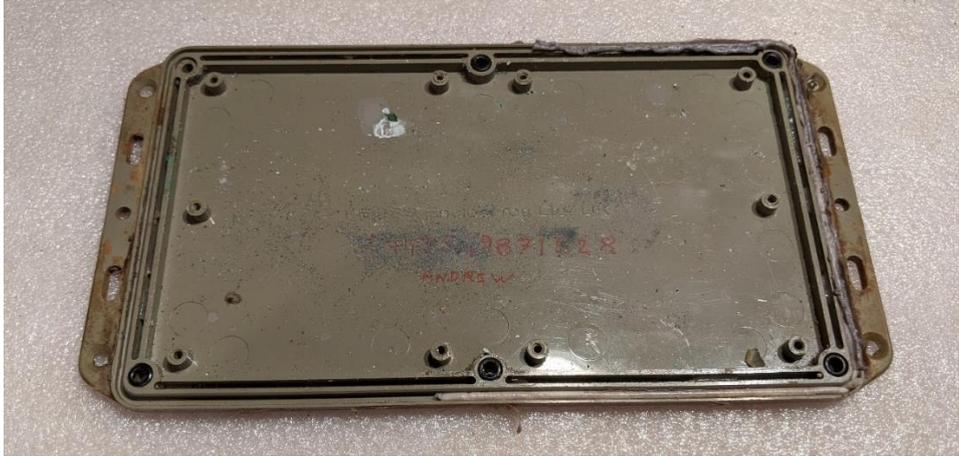
**Figure 4: Unit #3888 Housing Base**

The base of the Housing (Figure 4) contained what appeared to be very small chips of 'sparkly' material. This was established to be conformal coating which had come off the electronic parts due to a combination of thermal cycling and vibration of the unit.

1. Use a thin layer of clear two-part epoxy as conformal coating on both sides of the Electronics board. (This will avoid the conformal coating cracking off under vibration) Also, ensure the all housing's top surface is abraded to assist solar cell adhesion.

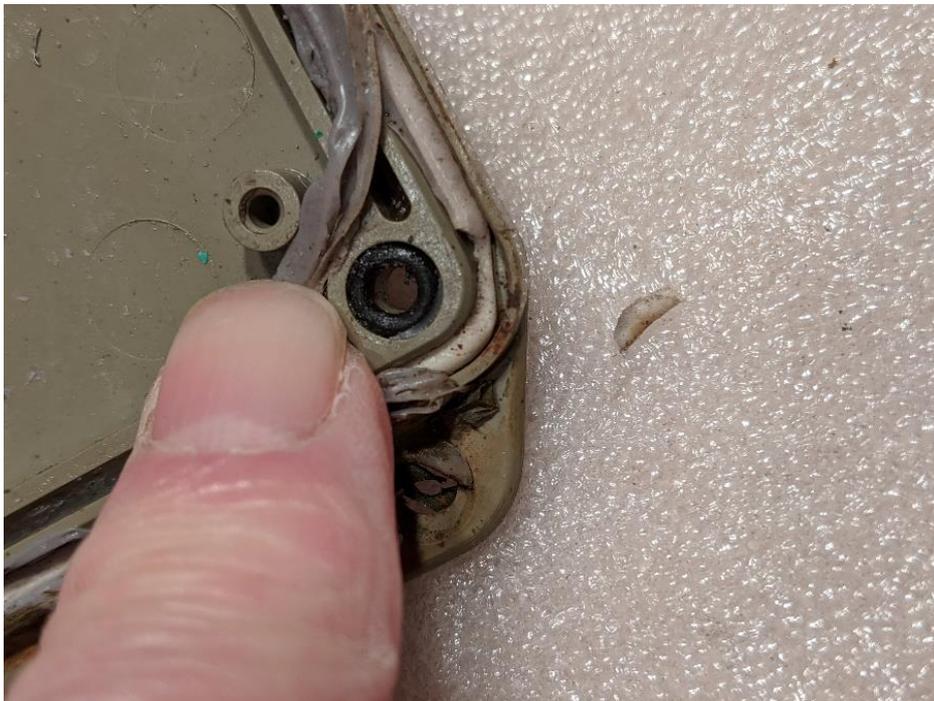
**Figure 5: Unit #3888 Housing Base's Distressed White Rubber Seal**

The housing's base gasket appeared crushed and broken in a couple of areas, (Figure 5) but the application of the additional local sealant appeared to have worked well.

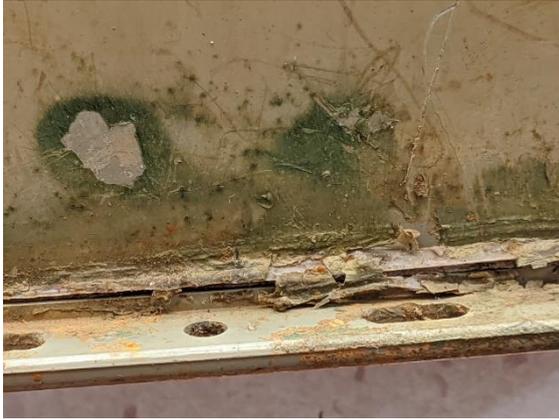
**Figure 6: Flaking Near Well Riser**

Figure 6 shows the housing's external surface flaking and mold next the water riser. Figure 7 shows the impression of a possible additional local fixing between the solar cells and the well's spout.

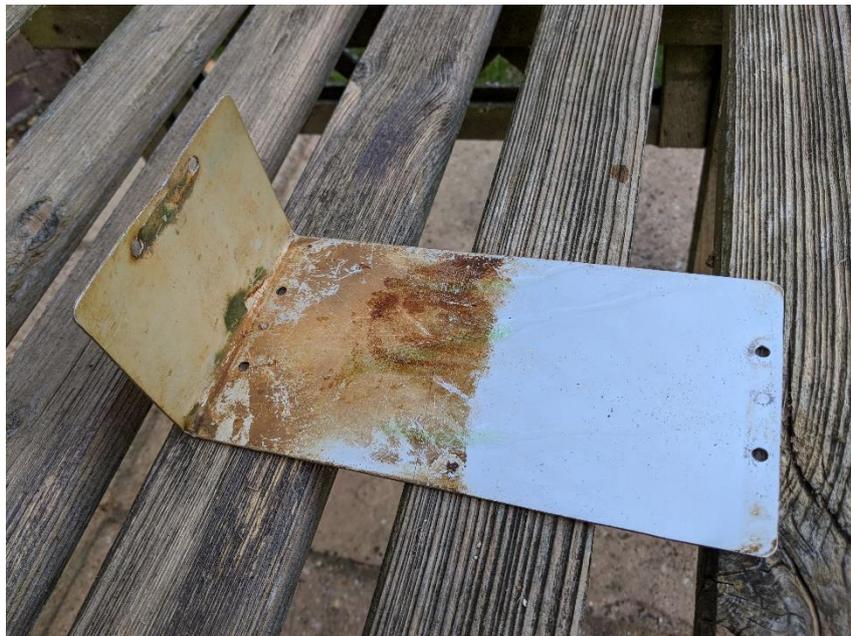
**Figure 8: Aluminium Base Plate**

The overall impression of the aluminium base plate is that it has rusted. ( $\text{FeO}_2$ ). It is very difficult and highly unlikely for iron oxide to occur this way. When aluminium oxidizes it turns a slightly lighter colour, ( $\text{AlO}_2$ ) not rust brown. Investigations show that it the colour is more likely the result of mixing and baking (by the heat of the sun) high levels of dirt dust and water. (Which could be high in iron salts). The application of a small amount of water and elbow grease shows the bright aluminium underneath. (Figure 8). There are small visible signs of pitting which could have been caused by trapped grit particles combined with spout vibration. There is no other sign of chemical degradation of the metal.

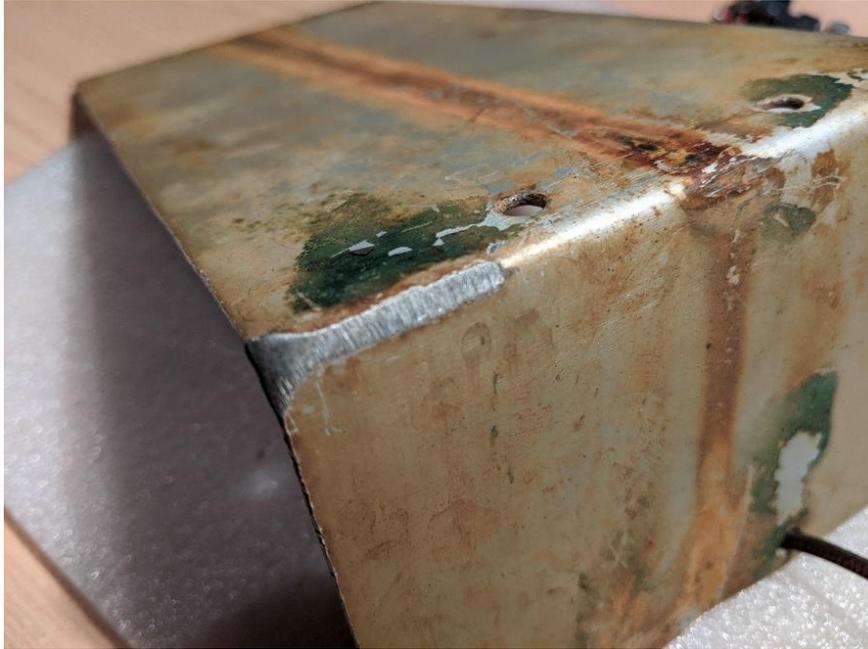
**Figure 9: Base Plate Corner Stress**

In addition to the compacted mud deposit, the Base Plate has undergone some physical stress. The corner next to the spout is scuffed. Figure 9.

This has not damaged the housing. However if the AWSOM unit was attached to the Base Plate during the time of the occurrence, the amount of force needed to scuff the aluminium would have stressed the internal circuit board.

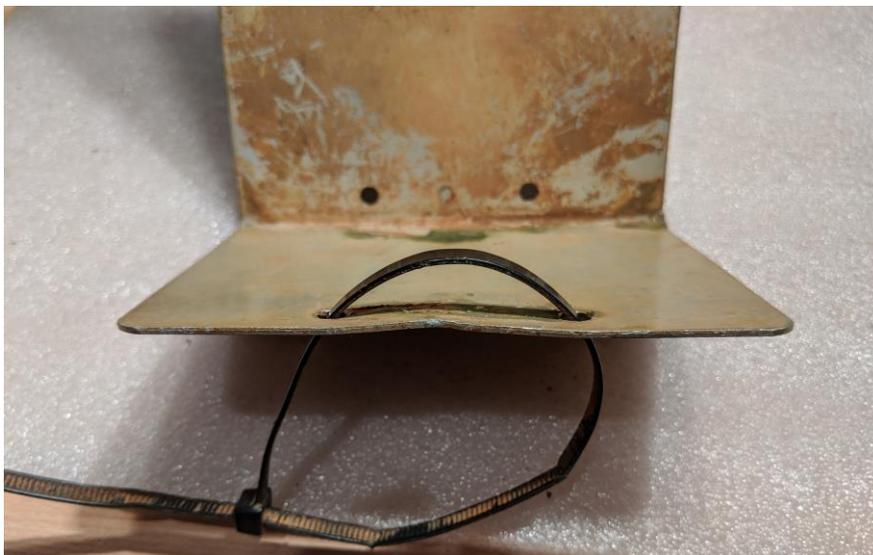
**Figure 10: Vertical Plate Warping**

There is a slight bending of the Base Plate's vertical support at the riser-pipe end. This could be the result of strongly attaching the Unit to the well riser pipe. (Figure10). A slightly thicker Base Plate could be used in future versions. (2mm)

3. Make the aluminium base plate 2 mm thick rather than the current 1.5 mm thick. (To prevent bending)
4. Construct the unit so that there is no need to open the housing after UK testing. (To prevent dust ingress etc.)

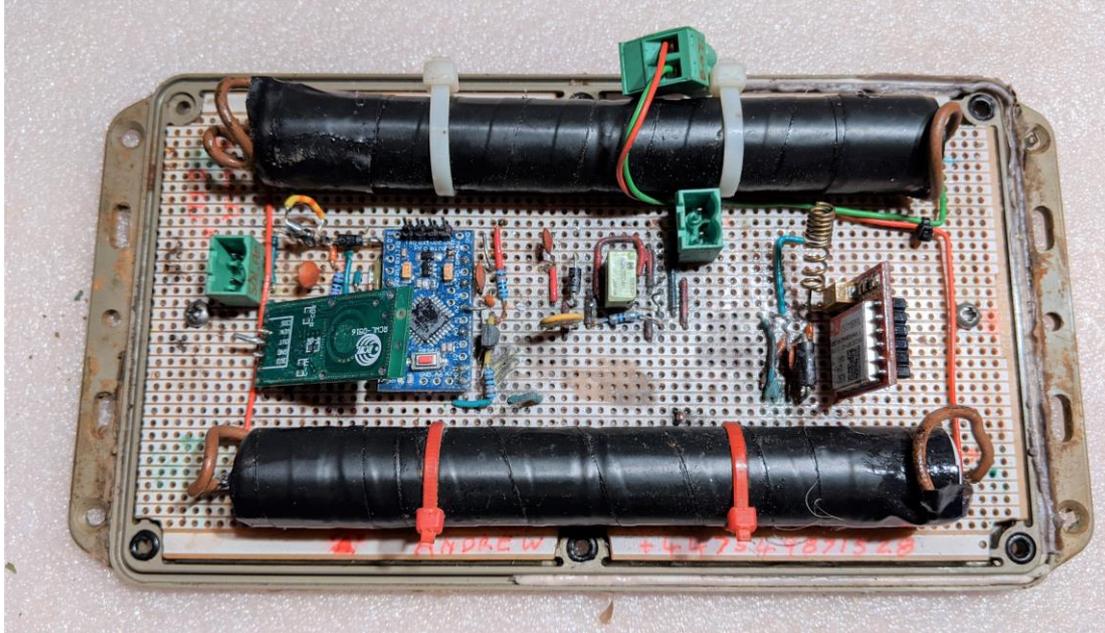
**Figure 11: Main Electronics Board Post Installation**

The overall impression of the Main Electronics Board was 'Stress'. The stress could be due to a combination of: physical impact, water ingress, temperature cycling & long-lasting vibrations that the unit experienced.

Figure 11 above shows the Unit circuit board as returned to the UK.

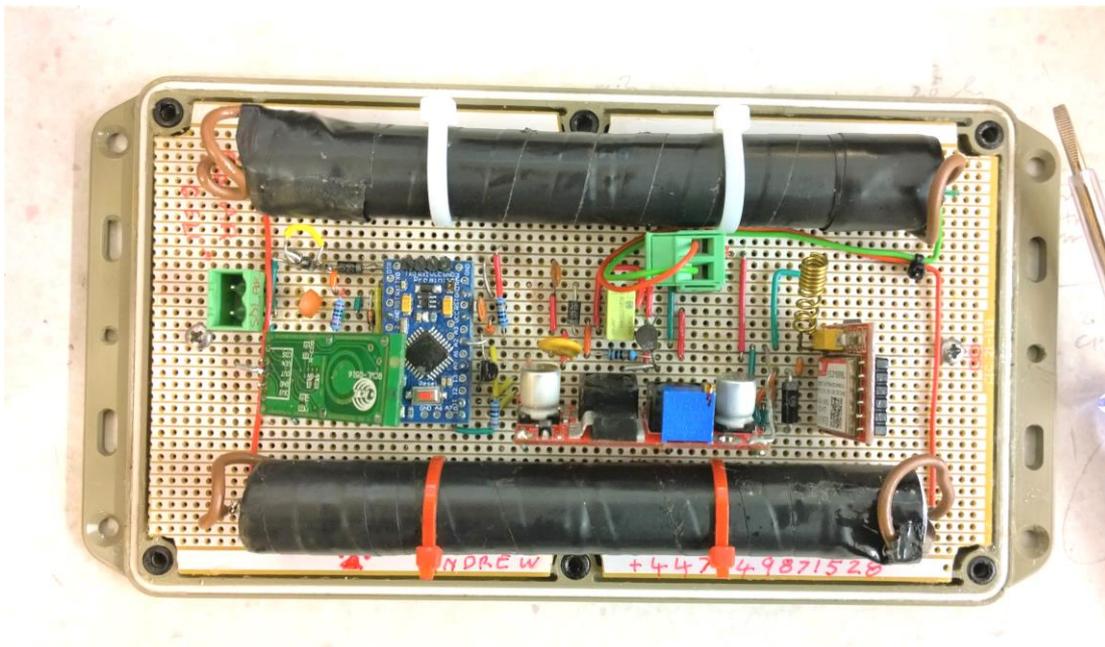
**Figure 12: Main Electronics Board Export**

Figure 12 below shows the Unit pre-export.

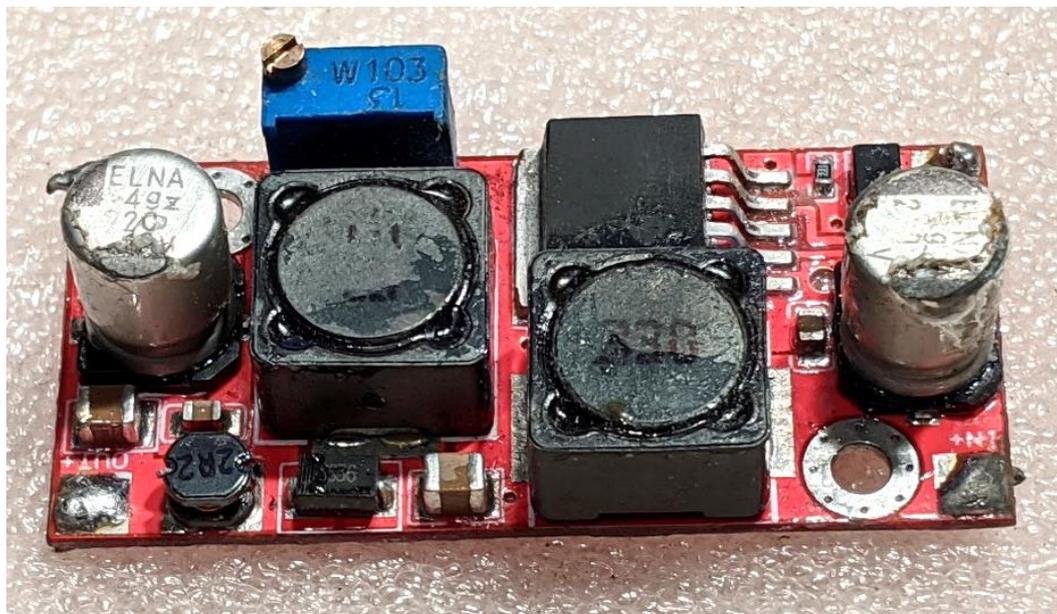
**Figure 13: SIM Voltage Regulator**

The large Central 4.1V SIM voltage regulator should be attached to the Vero-board through four soldered joints. This unit was loose in the box upon arrival in the UK. Without the voltage regulator the SIM texting module would not have been able to power-up.

The regulator could have become loose due to some unknown physical action or through the continual vibration of the unit on the well spout. The continual vibration could have caused metal fatigue in each of the four wires connecting it to the Main Electronics board. As the board is mounted vertically the vibrational stress could have been instrumental in freeing the regulator.

Additional stress was noted on the voltage regulator. The two I/O capacitors have undergone surface abrasion. The abrasion to the plastic coating can be seen in figure 13.

The scuffing of the two silver colored capacitors is from an unknown source. The scuffs are in line with each other and in the same direction an angle (up/down & at 45 degrees).

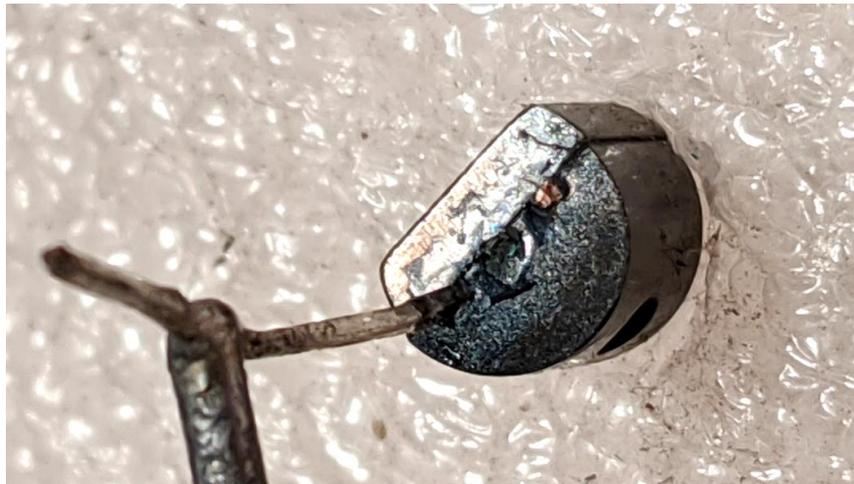
**Figure 14: Computer Voltage Regulator**

The main computer on the circuit board is an Arduino mini pro. It provides all the logic functions, codes and sends and records the texts and all the data. The Arduino computer is driven by a 5 V regulator. This Voltage regulator also came detached from the Electronics board. Two of its three wires were broken at its base. This small 5V low volt-drop regulator is about the size of a garden pea and is of low mass. It is unlikely therefore that vibration alone could have caused the breakage of these two wires.

The Arduino voltage regulator (Figure 14) was situated very close to the power relay. (See figure 12) In addition to the voltage regulators the control relay's mechanical integrity has been compromised in one corner. The damage to the control relay is close to where the computer regulator would have been. The close proximity of these two units could have meant that one adversely affected the other.

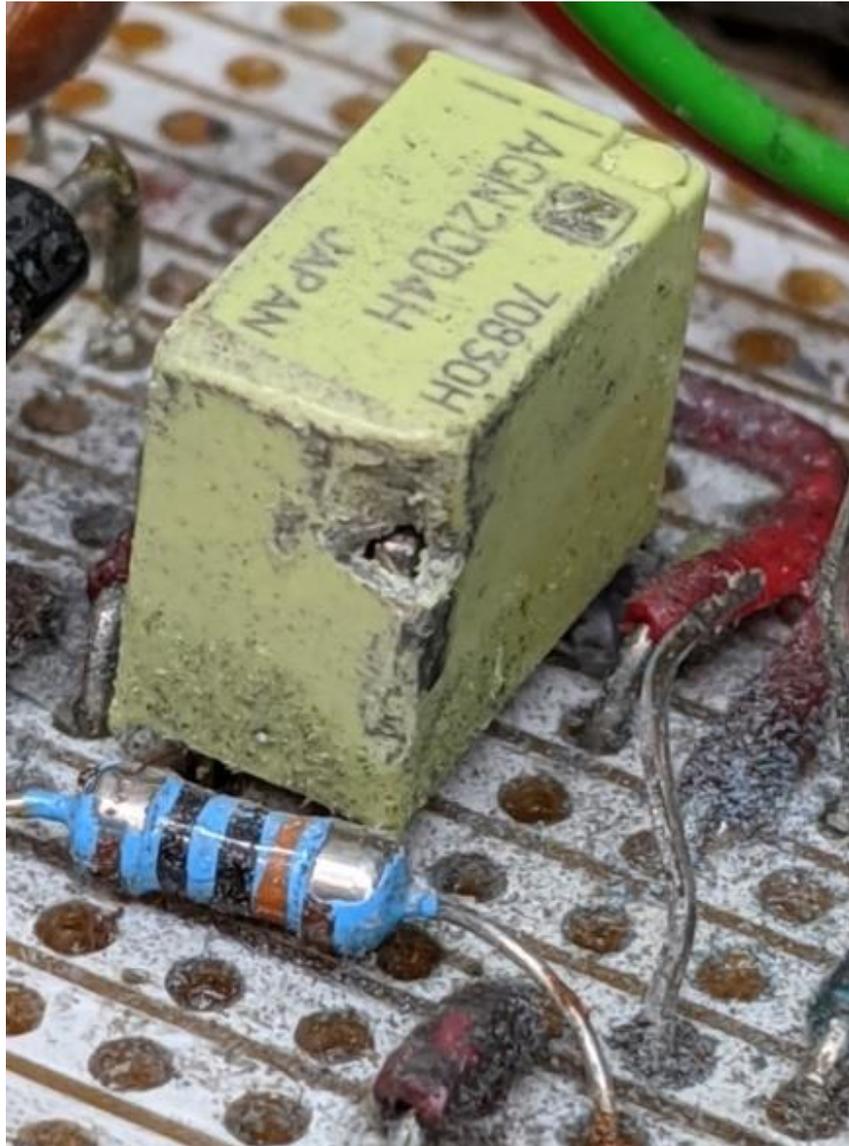
**Figure 15: Control Relay**

The control relay switches the power to the SIM texting module and diverts power away from the battery when an overcharge is detected. The integrity of the relay's housing has been compromised (Figure 15). It must be remembered that this corner is closest to where the 5V regulator would have been.

Chipping off the corner of the relay needed a high level of force. The resistor below is still operational but has also suffered damage. Whether this damage was the result of a mini-explosion inside the relay or is the result of accidental impact is unknown at this time.

Discussions with RS-Components said that they could not help directly as I had last purchased a relay of this type over a year ago (July 2018). RS Components (the relay suppliers) pointed me in the direction of the manufacturer, Panasonic. Discussions with Panasonic in the USA continue as to the failure modes of these type of relays. Photographs are being sent to the USA for analysis. The response of Panasonic is awaited. (The resistor below the relay could be indicative of what happened)

The level of dust and debris on the circuit board is apparent from figure 15. Although the wires look black and burnt they had not got that hot as the black coating was easily removed revealing the PVC underneath, it was clear and undamaged.

6. Consider whether the relay specification must be improved (Discussion with the USA supplier continue on relay failure modes).

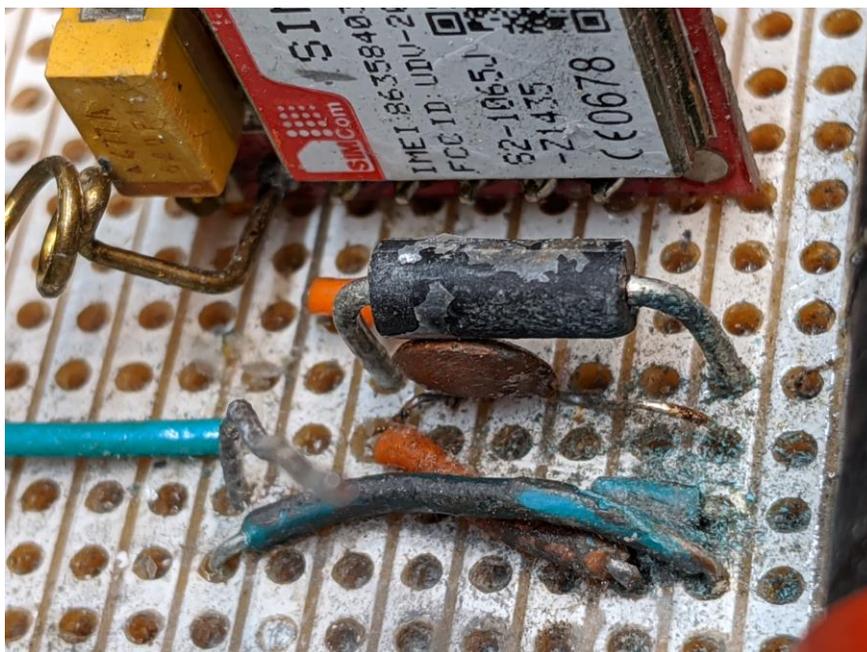
Figure 16: Chipped Conformal Coating on Zener

The conformal coating used was an acrylic clear paint-like material. It is used to cover all the electronic components. This coating protects the board from water damage. The coating is tough but can be melted or cracked off the components when required. The cracked coating on the black Zener diode in Figure 16 should be noted. There is also a significant level of debris on the board. The blue wire has been coated with an unknown black substance. (mud/dust?) The black residue can be removed ( Figure 16) by low levels of abrasion.

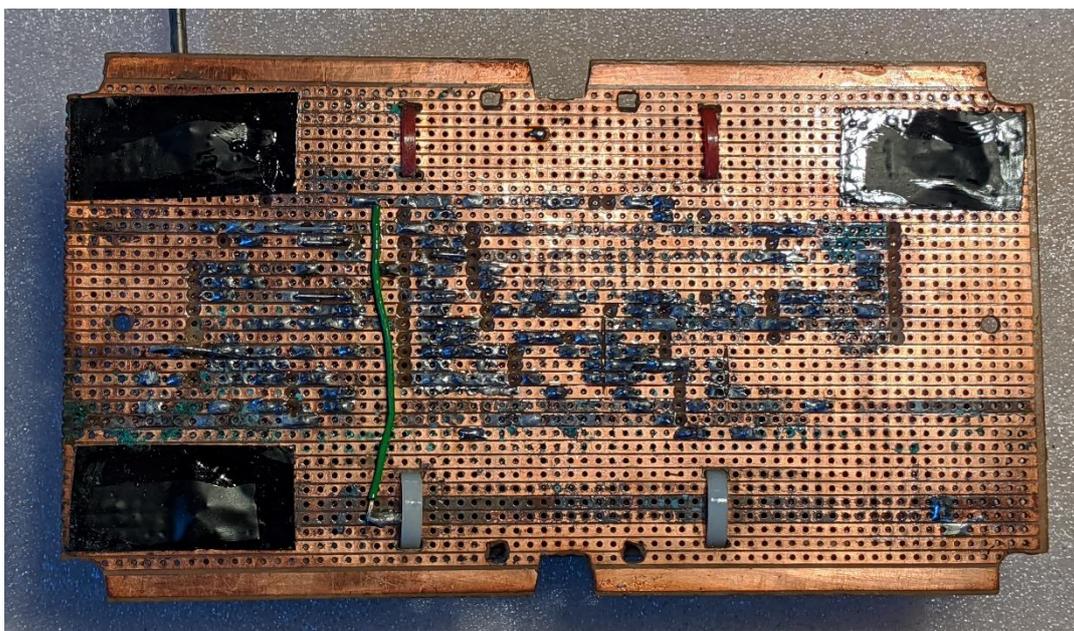
Figure 17: Conformal Coating - Track Side

The wet-look to Figure 17 and Figure 18 is the conformal coating on the copper tracks. Track degradation appears to follow the high voltage (5v) power lines (bottom of figure 17). Figure 18 shows some of the detail of copper degradation on the upper-right of the board.

2. Ensure the copper tracks of the positive and ground lines are not adjacent to eachother and are as substantial as possible. (To avoid 'high' voltage differences between closely spaced tracks and possible track corrosion).

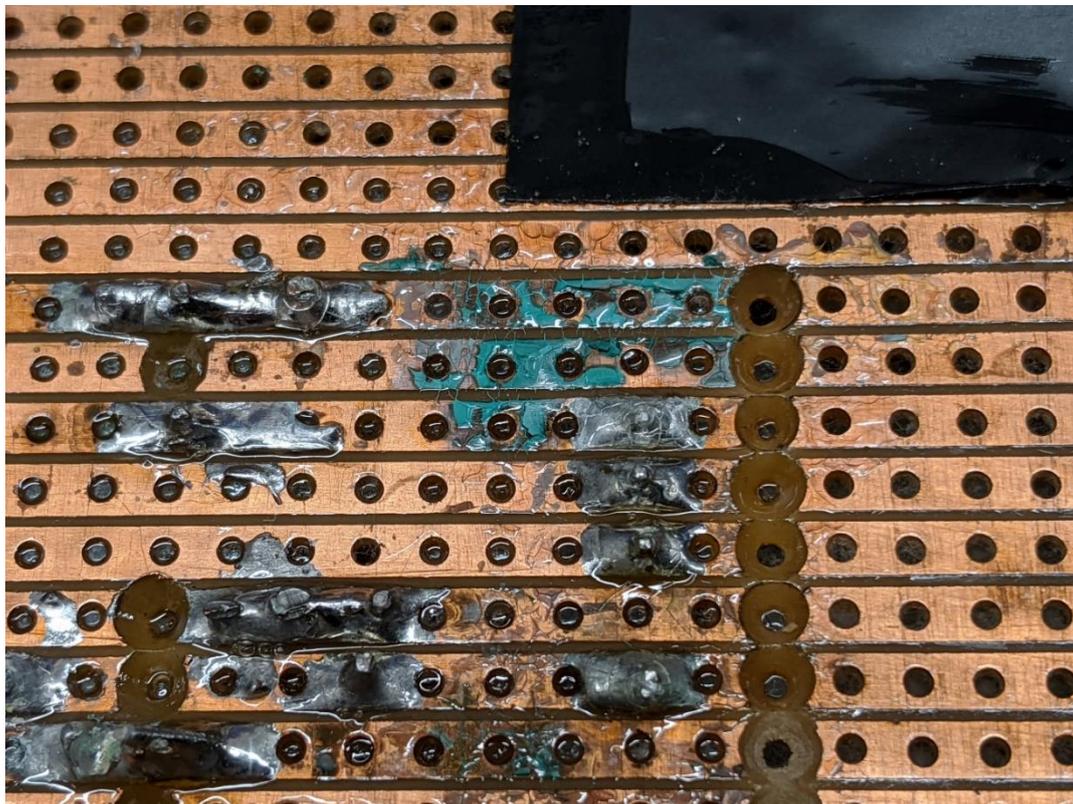
**Figure 18: Conformal Coating Degradation**

The wet-look on this board (Figure 18) shows the extent and the coverage of the conformal coating. The green areas in the middle of the picture indicate where the copper has been eroded and oxidized and where the conformal coating failed. It is unclear whether water ingress was from the bottom trackside or through the holes in the top of the board. In future units the conformal coating must be more flexible and tolerant of vibrational stress. (NB: The airborne Radar & defense industry have occasionally used a thin layer of two part epoxy resin successfully)

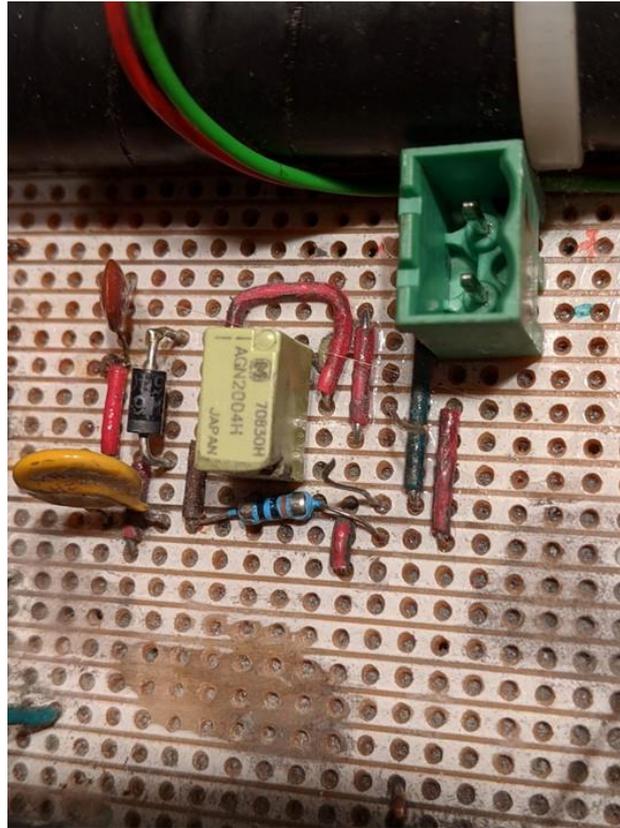
**Figure 19: Vero Board Base Layer Exposed**

Some unusual markings appeared on top of the Vero board. The white covering on the Vero board was missing. It is unclear how this occurred. Very high levels of abrasion are needed to remove the white coating. A combination of heat, temperature cycling, dust and some form of vibration could have removed the covering but it is unclear precisely how this occurred. Figure 19 shows a patch where the white-coating has been lost and the Vero board base layer exposed.
